**FETCHAM CHURCH**

THREE.ESSAYS ON THE HISTORY OF ST. MARY'S CHURCH

by John Mettam

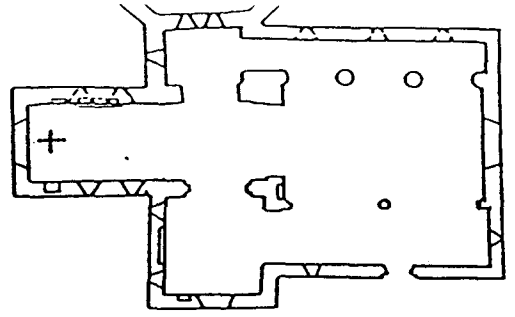
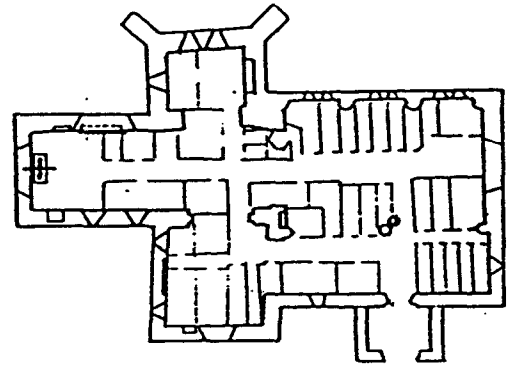
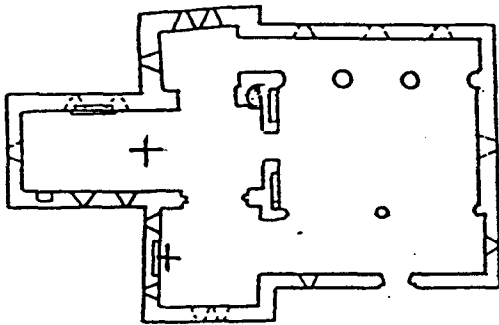
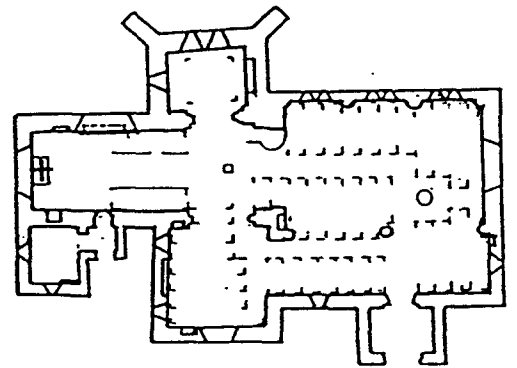
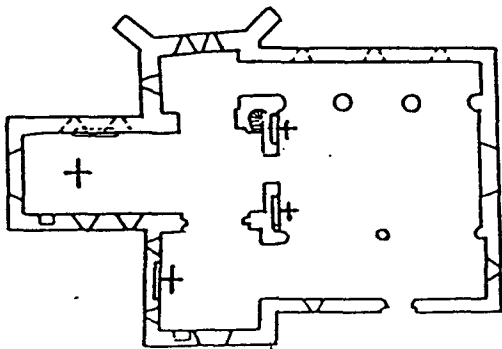
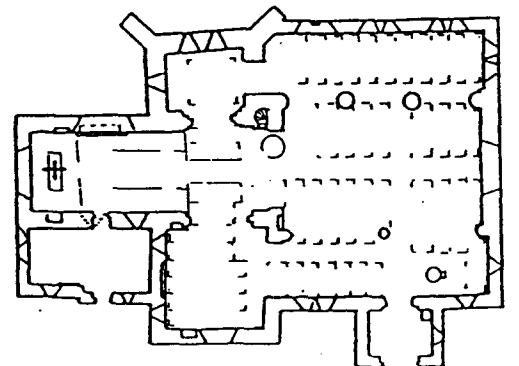
Figure 9 Development Stages

(i) Ca. 1000

(v) 17<sup>th</sup> Century ?

(ii) Ca. 1200

(vi) Up to 1857

(iii) Ca. 1300

(vii) 1872/7

The most probable sequence of development is shown in Figure 9. This may be read in conjunction with Figures 6 & 7.

Starting with the Late Anglo-Saxon two cell church, shown in Diagram (i), circa 1000, in Figure 9, I have two main suggestions.

(Broken lines are used in Figure 9 to show the recesses and the stairs to indicate the controversial nature of dating them so early).

Broken lines are also used in Figure 9 for the door and all except one of the windows as we have no evidence of the exact

In Diagram (iv) of Figure 9 I have followed VCH in adding buttresses to the Tower, but they gave no evidence for this. I know no reason for assigning this date for features which could have been included in the original construction in 12th Century or have been part of the repairs in 17th and 18th Centuries.

The arrangement up to 1857 is indicated in Diagram (vi) of Figure 9 as well as in Figure 4. These show how, after collapse of the South Aisle, every space was needed for pews, which are provided in the North Transept, in the Chancel and even into the Tower Arch (the Tower also held the Vestry) . The old, 1632, stone font appears beside the central column of the North Arcade. An organ was provided beneath the West Window. The pulpit and reading desk are on the south side of the Chancel, so if a new pulpit was built on the north side of the Chancel in 1761 the 1857 layout belongs to a later date.

Figure 5, and Diagram (vii) in Figure 9, show the arrangement in 1872 when the restoration of the Chancel was completed (with, possibly, some changes up to 1877 when the drawings were used for the contract for reconstruction of the South Aisle) . The pew layout was probably adopted in 1857 when a contribution of £20 towards the cost was provided by the Incorporated Society for Building.... Churches, on condition that 108 seats were provided for the poor inhabitants of the parish. The Victorian font of 1868 had by then replaced the 1632 font but it was not yet in its present position just inside the door. In 1877, the

The final diagram on Fig 9 shows the arrangement of the church early in the 20th Century including the work carried out in 1877 and the completion of the Vestry. The seating layout, inferred from a photograph of the period, combines the cross-seating in the North Transept with the present pew arrangement throughout the rest of the church. This includes the choir stalls separated then by a screen from the Chancel. The surpliced choir, which we now tend to think of as an old tradition would have been a Victorian introduction accounting no doubt for the extension of the Vestry, so soon after it had been built to make room under the Tower for the Father Willis organ which still accompanies our services. Pulpit and lectern were under the Chancel Arch close to the old Rood Stairs. At this period the church was rather heavily decorated in the Victorian taste. This has now been changed to suit current taste and the Lady Chapel re-established but the major repairs carried out by the Moon and Hankey families in the Victorian period have served us well.
